# UNDERWATER BRIDGE INSPECTION REPORT

STRUCTURE NO. 7208

BLUE EARTH RIVER

MINNESOTA DEPARTMENT OF TRANSPORTATION  
UNDERWATER BRIDGE INSPECTION

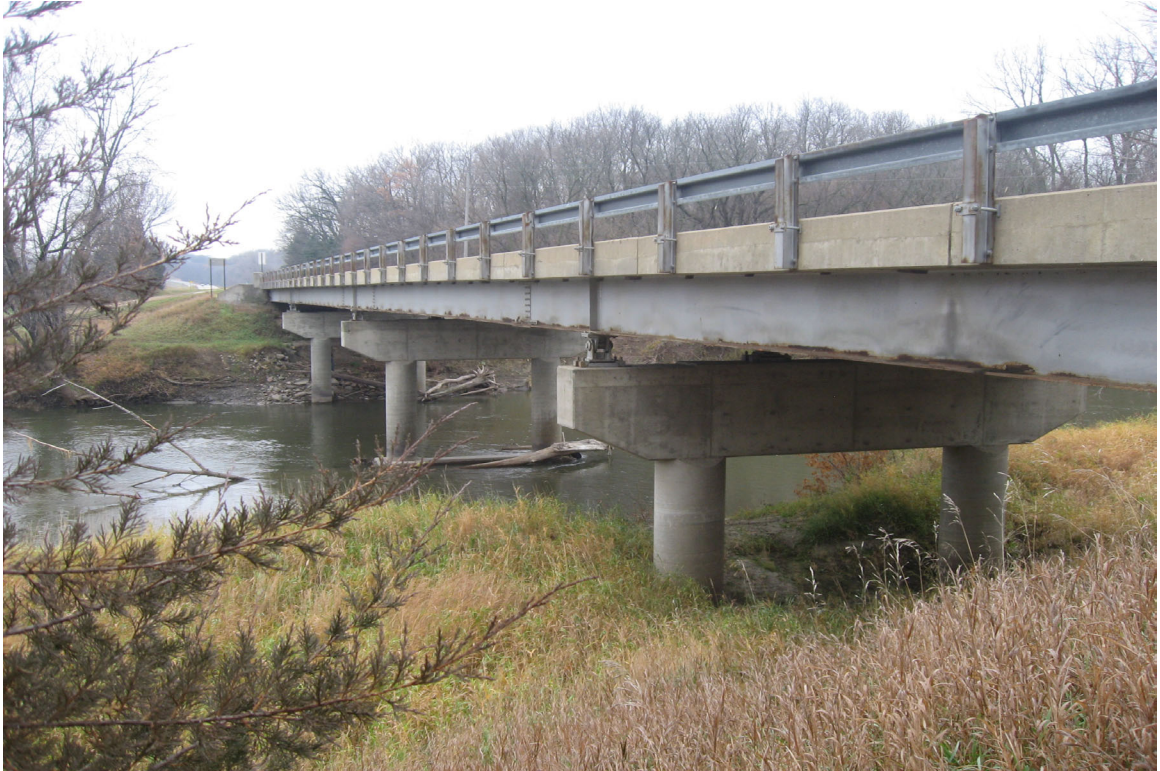
Photograph 1. Overall View of the Structure, Looking Southeast.

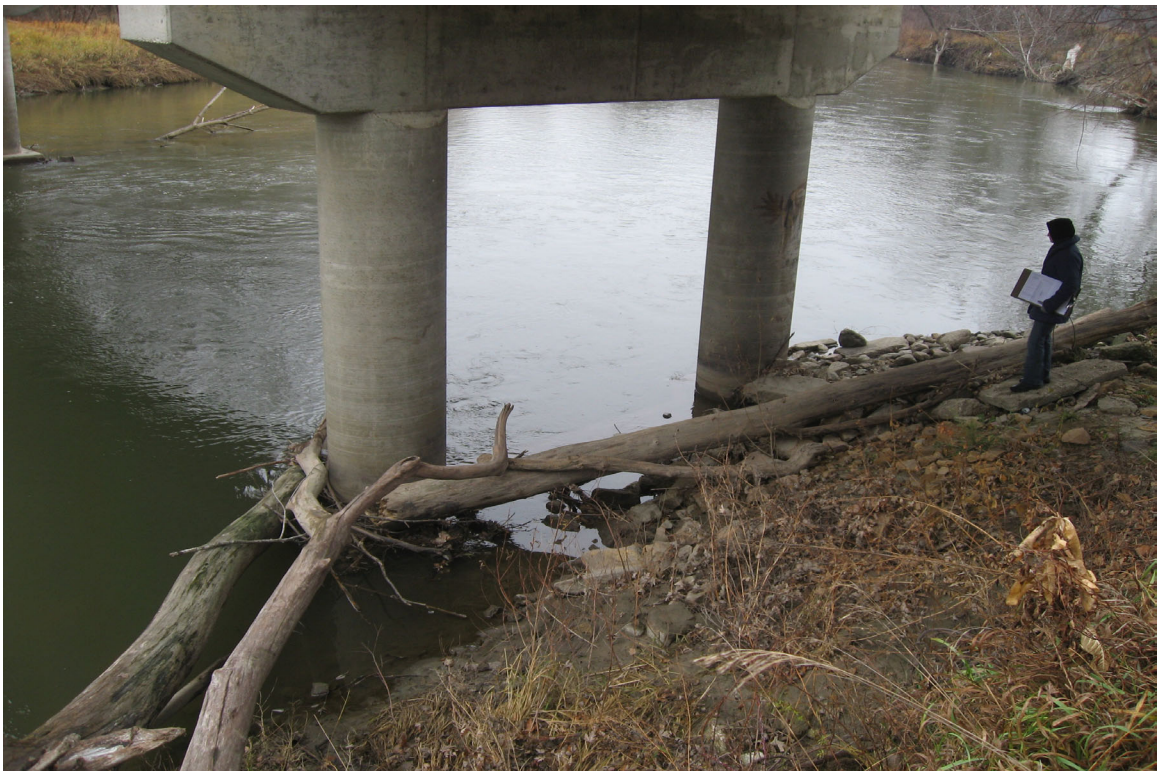
Photograph 2. View of Pier 3, Looking North.

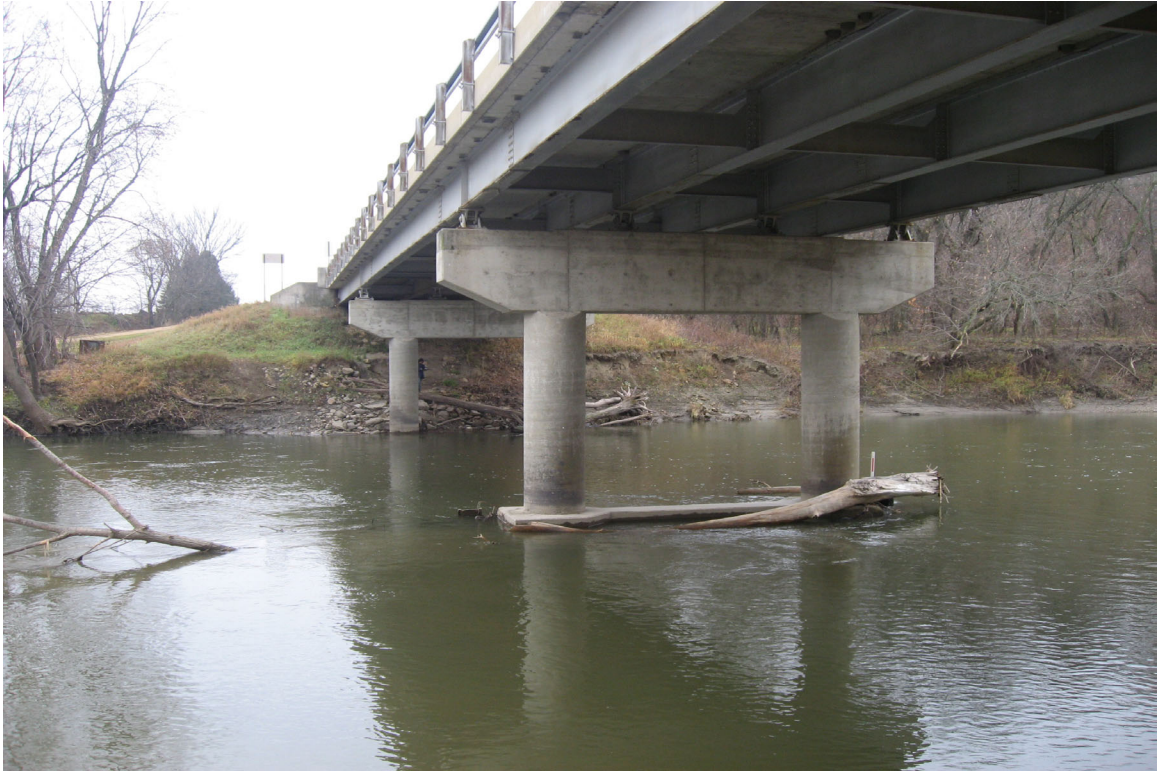
Photograph 3. View of Pier 2, Looking Southeast.

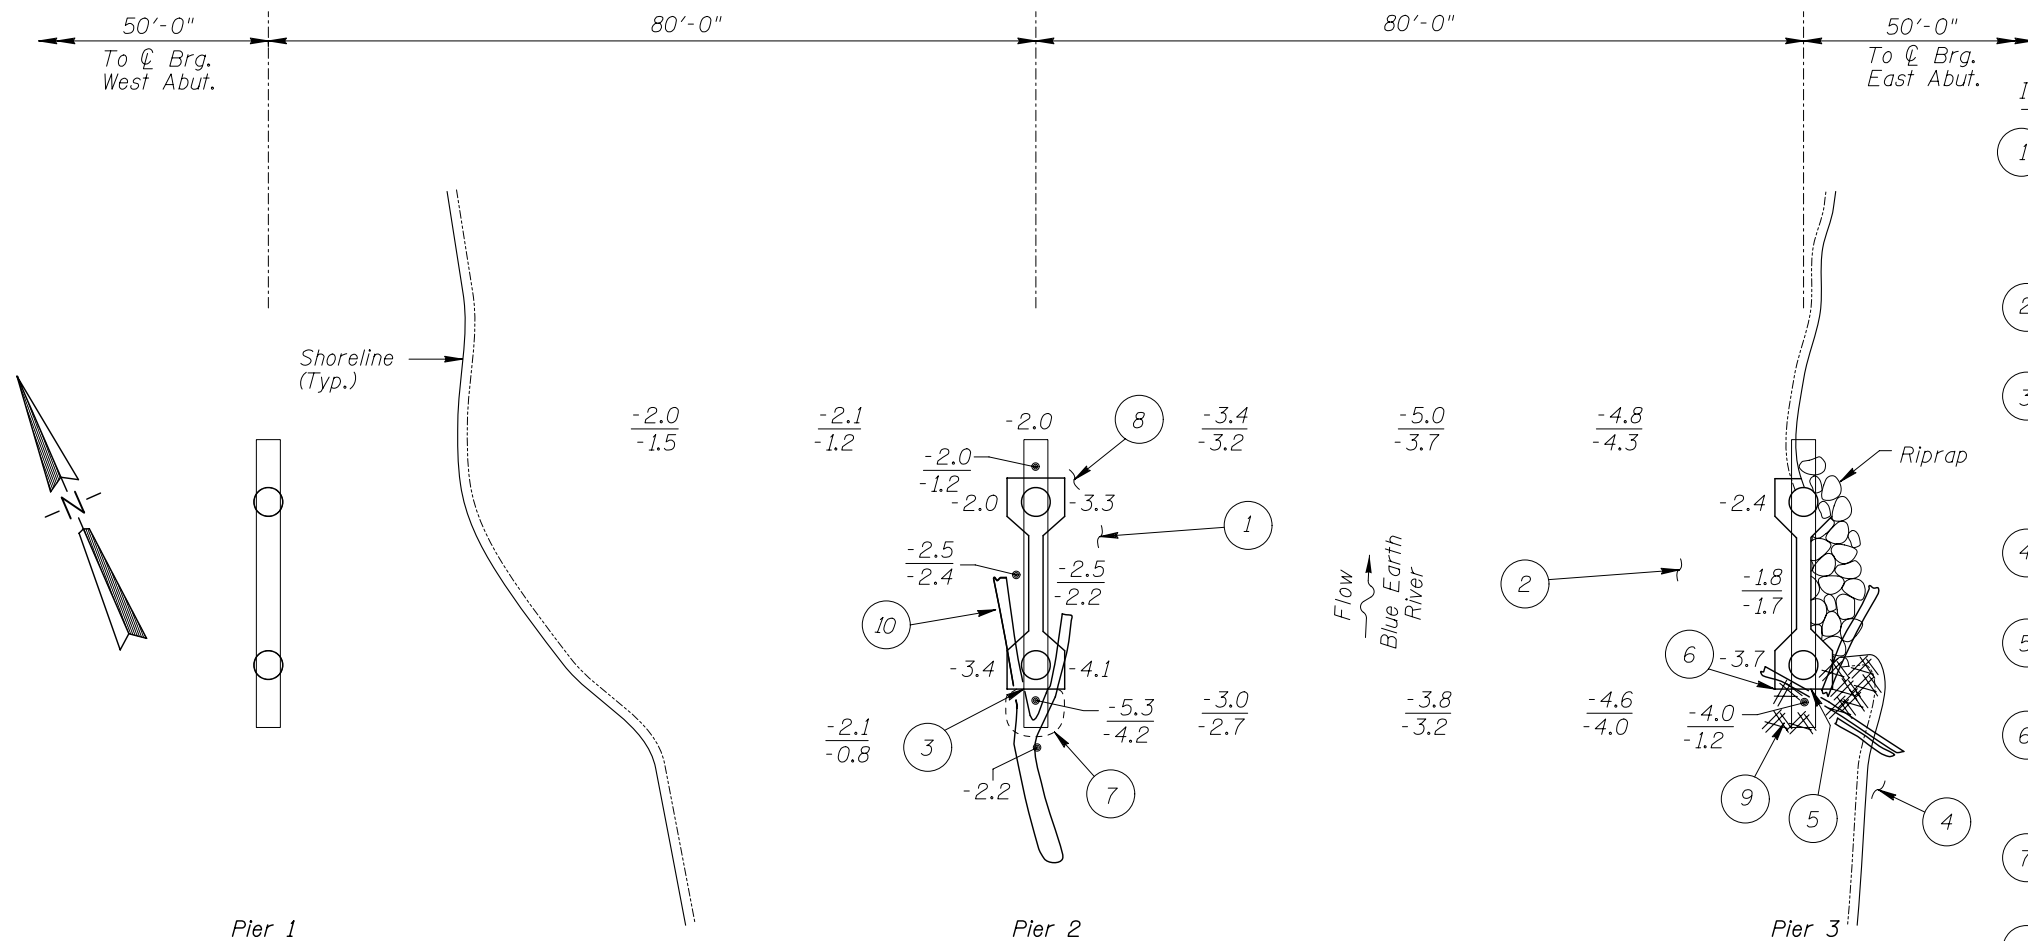
**INSPECTION AND SOUNDING PLAN**

- The channel bottom at Pier 2 consisted of silty sand and gravel on the west side and riprap, up to 2 foot in diameter, along the east side and upstream nose. When possible, there was up to 6 inches of maximum probe rod penetration.

- The channel bottom consisted of cobbles up to 1 foot in diameter with no appreciable probe rod penetration.
- An area of section loss, 1.5 foot high and extending the entire width of Pier 2 was observed at the top corner of the webwall at the upstream end with a maximum penetration of 6 inches and vertical exposed reinforcing steel at the corners.

- Moderate erosion of the embankment was observed at the upstream end of Pier 3.
- A hairline crack was observed at the upstream end of Pier 3 extending from the top of the webwall to the channel bottom.

- An area of section loss, 7 inches high and 12 inches long, was observed at the top corner of the webwall at the upstream end of Pier 3 with 1 inch of penetration.

- A scour depression, 2 feet deep and 7 feet in radius, was observed at the upstream end of Pier 2.
- A piece of steel sheet piling was observed at the downstream end of Pier 2 extending from the channel bottom to 1 foot above the waterline.

- A moderate to heavy accumulation of timber debris consisting of logs and branches 1.5 feet in diameter and smaller was observed at the upstream end of Pier 3 extending from the shoreline to the upstream column and resting on the webwall.

- A large, 30-foot-long log, 1 foot in diameter, was forked on the upstream column of Pier 2 resting on webwall.

The corner spall in the top of the web wall at Pier 2, which has exposed reinforcing steel, should be monitored at the minimum. If found to be progressing in size, the area should then be repaired by removing all unsound concrete, cleaning the exposed reinforcing steel, and patching with a concrete mix designed to promote high durability and low permeability.

Monitor the timber debris at Piers 2 and 3, and if found to be increasing in the future, removal operations may become warranted.

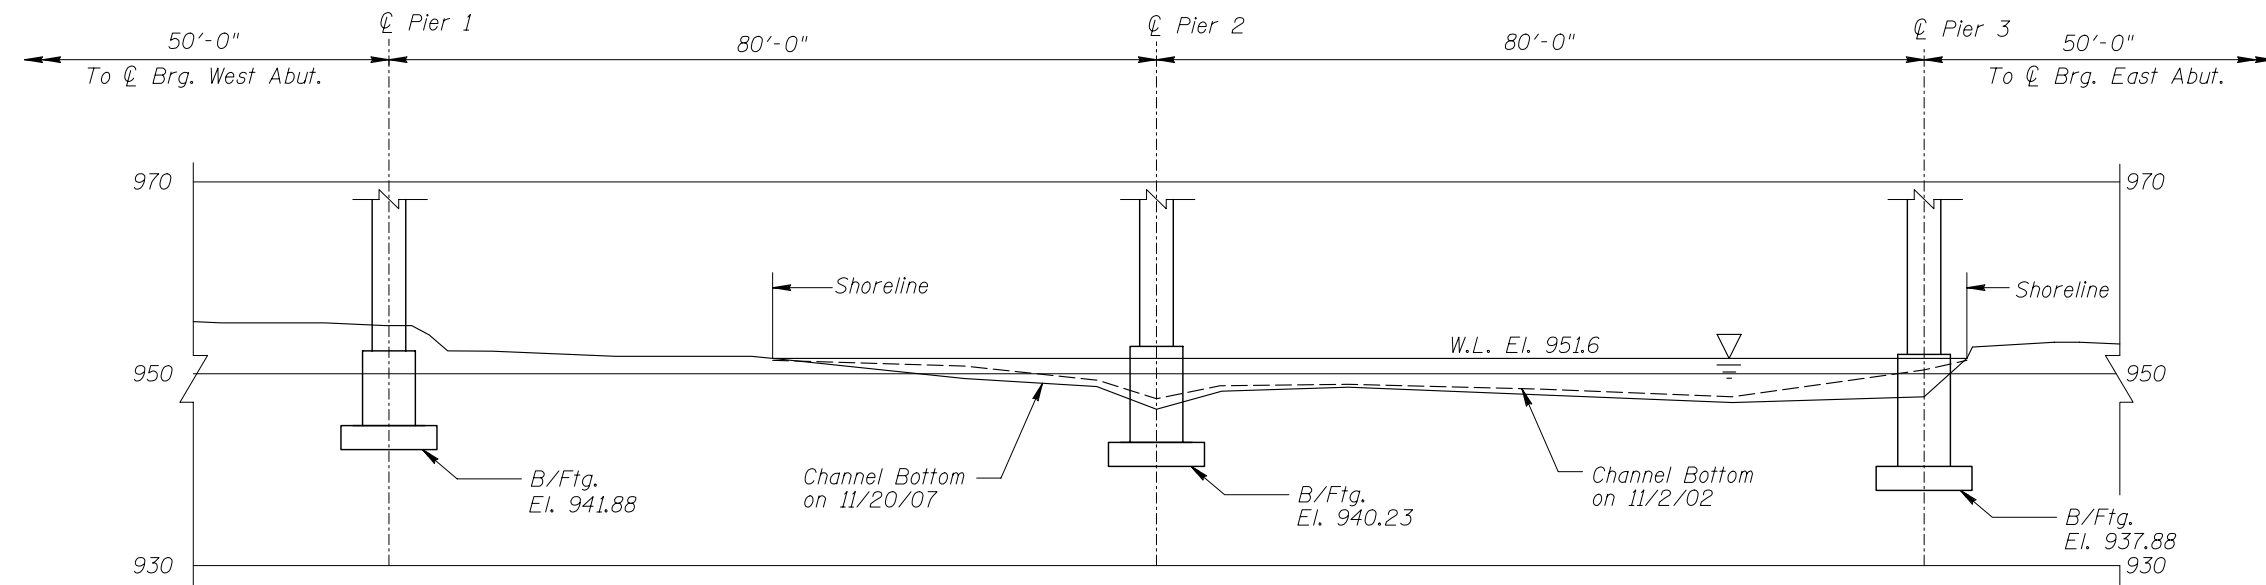
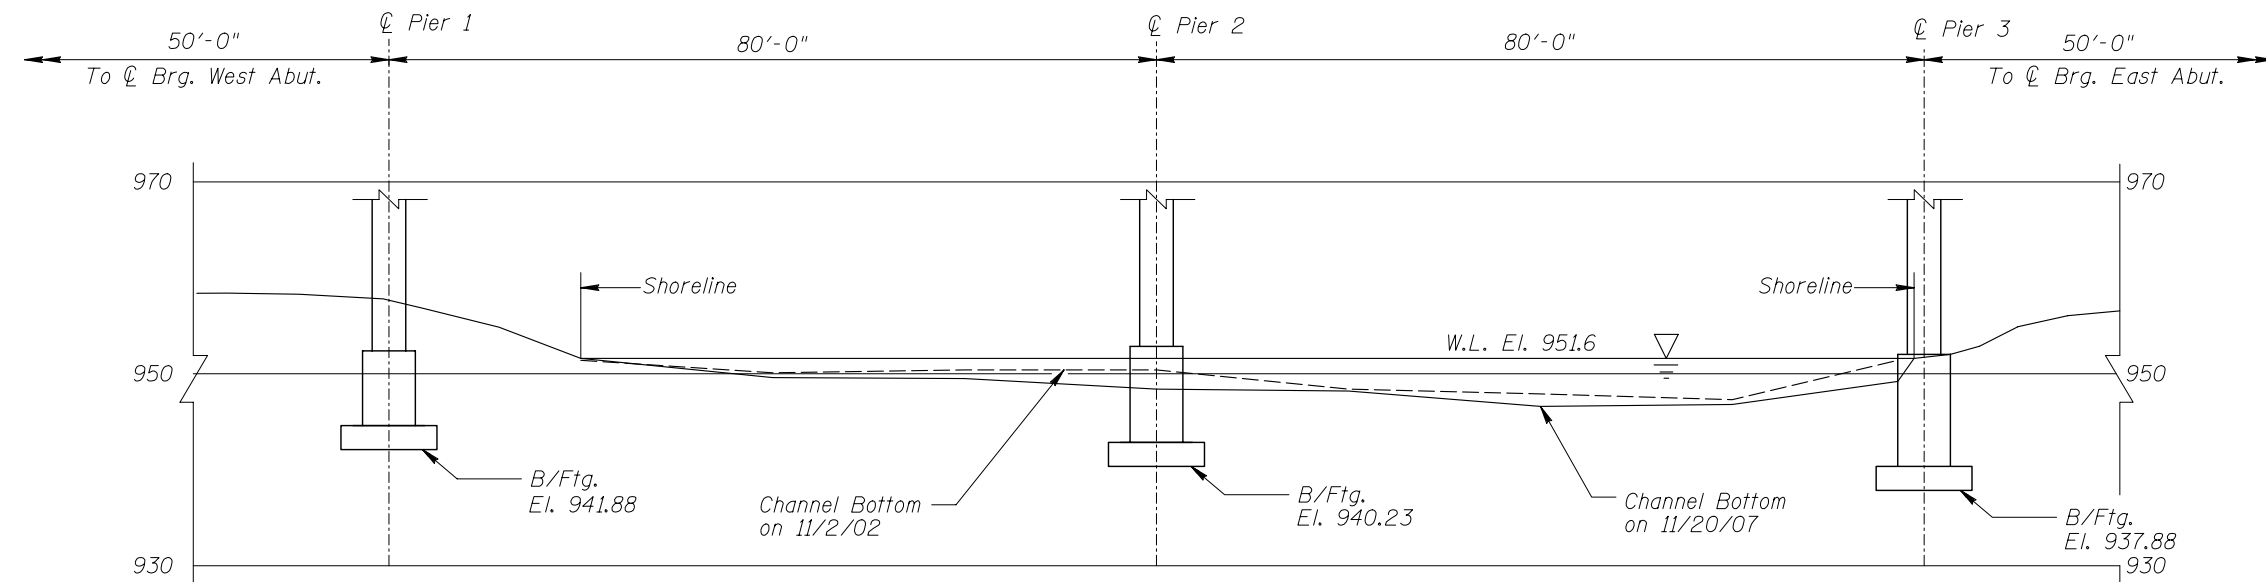
UPSTREAM FASCIA PROFILE

DOWNSTREAM FASCIA PROFILE
